951 Kensington East, Munster, IN

Inspection Date:
09/08/2001

Prepared For:
John Smith

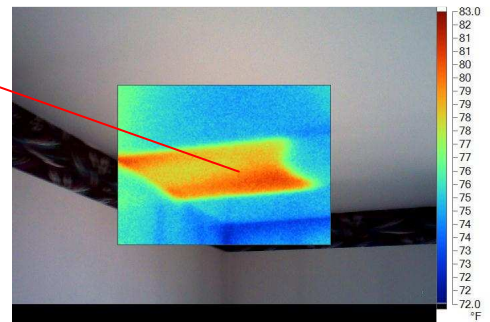
Refer to comment #15

15 Repair: Missing insulation was noticed at back right bedroom in back right corner of room. Common correction is re-installing insulation to prevent the chance of moisture issues and improve the efficiency of the house. Area is approximately 2 by 4 foot and can also be seen by the dark stain that is present.

Area of missing insulation.

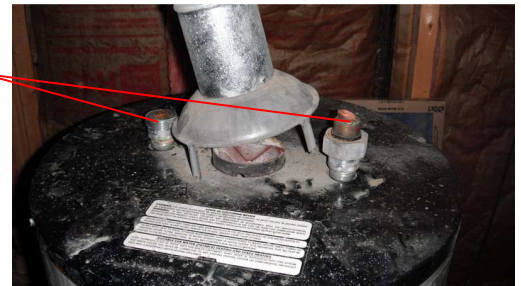
Refer to comment #16

16 Major Concern: Copper water plumbing pipes have been removed from house, which prevents anyone from properly living in the house. Installation of plumbing water pipes is needed.

Location where water pipes used to be installed.

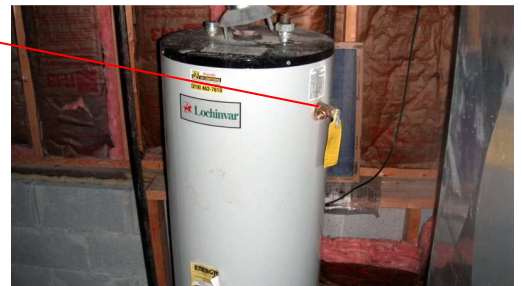
Refer to comment #17

17 Safety Issue: The discharge piping serving the Temperature and Pressure Relief (TPR) Valve for the water heater is undersized. TPR valve needs to have a 3/4 inch pipe terminated 6 inches from floor with no threads installed at the bottom of the pipe. Correction is needed to provide proper safety for homeowner.

Location where TPR valve pipe needs to be installed.

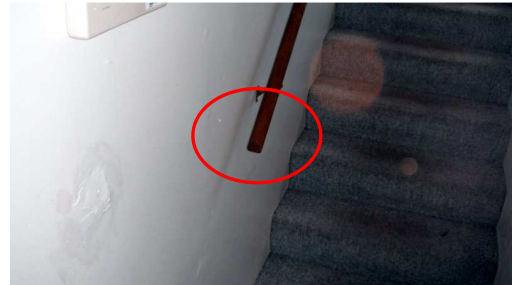
Refer to comment #19

19 Improve: Handrail at stairs to upper and lower levels does not return to the wall. Handrail returning to the wall prevents items from getting caught on the railing, such as a shoulder bag or a jacket, which can result in loss of balance and falling down the stairs. Even though handrails returning back to wall were not required when the house was built, having the handrail return back to the wall is recommended as noted in the International Residential Code (IRC) Book R311.5.6.2, to prevent possible injury.

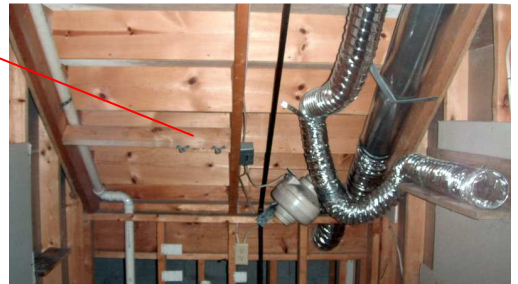
Refer to comment #20

20 Safety Issue: Drywall is not installed under stairs. Fire rated drywall (1/2-inch Gypsum Board) is needed to provide proper time for home occupants to exit house safely if a fire occurs. Correction is needed as noted in the International Residential Code (IRC) Book R311.2.2.

Drywall should be installed, especially since the washer and dryer are going to be located here.
